Re: Environmental Assessment Certificate (EAC) #E14-02: Schedule A (Project Description) – Request to Amend Condition #4 regarding Removal of Temporary Structures

Appendix A: Overview of Temporary Structures within the reservoir

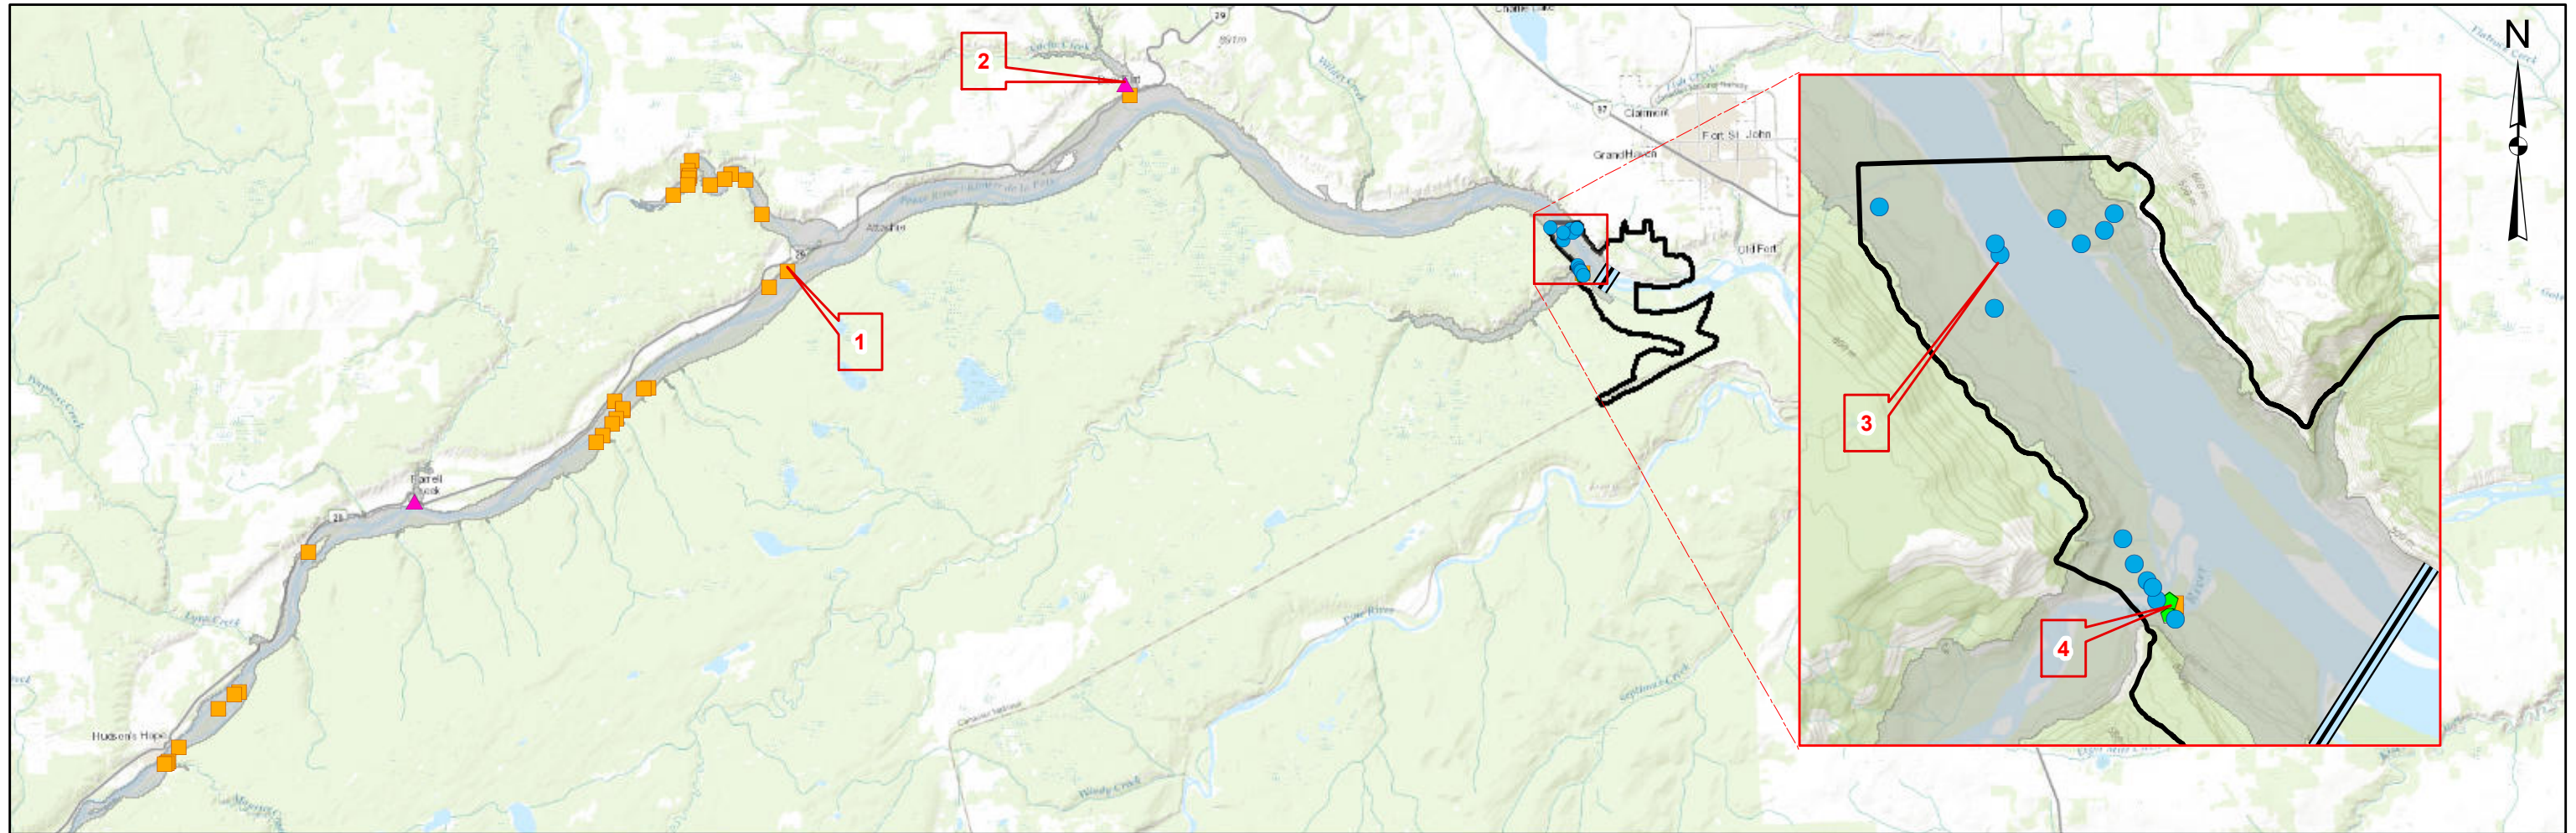
- Figure 1 (Overview) showing locations of proposed temporary structures to be retained.
- Note: Additional structures may be added as project planning develops.

Temporary structures include temporary causeways, diversions, debris boom anchors, and debris piles. Full reservoir capacity (i.e., elevation 461.8 masl) will inundate riverine habitat, permanently converting it to lacustrine-like reservoir habitat. The temporary structures will be inundated when the reservoir is at full capacity.

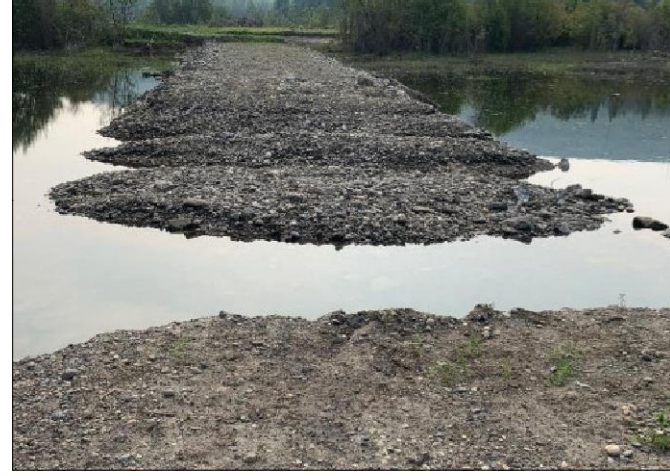
1 - Temporary Causeway for Reservoir Clearing (causeway example)

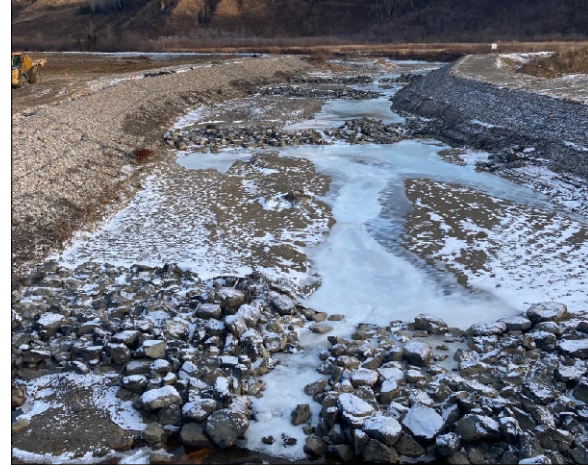
2 - Temporary Diversion at Cache Creek (similar diversion at Farrell Creek)

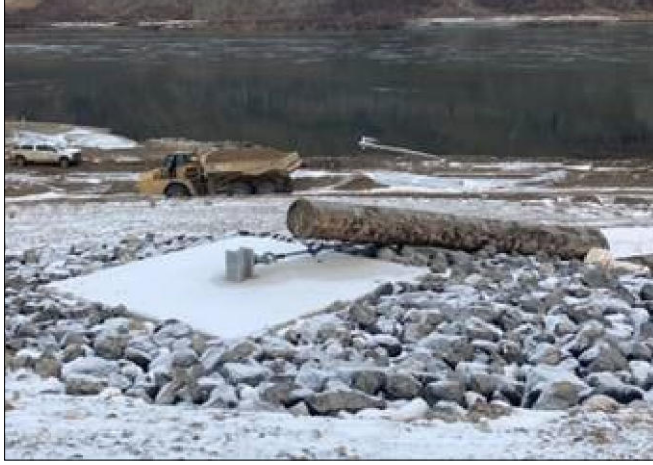
3 - Temporary Peace River Debris Boom Anchor (typical anchor)

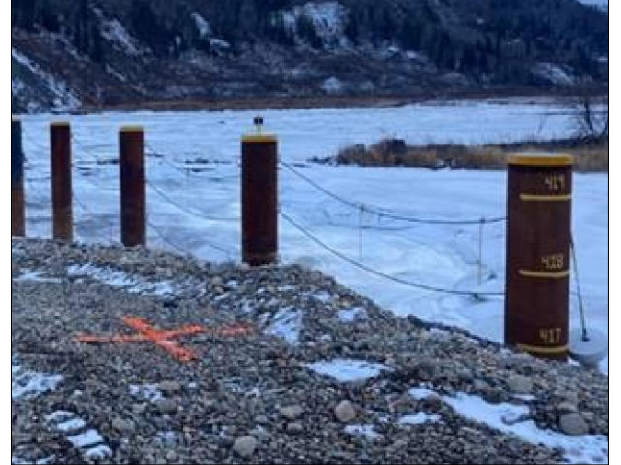
4 - Temporary Moberly River Debris Piles (example of piles)

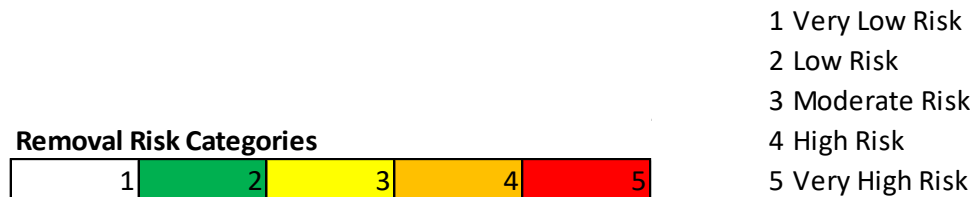
Figure 2: Overall Risk Ratings to Fish and Fish Habitat of Temporary Structure Removal

To assess the risk to fish and fish habitat of removing the portions of the temporary structures currently remaining instream through reservoir inundation, structure-specific risks associated with temporary structure removal at each location were considered. The risk ratings for this category ranged from 1 (low risk) to 5 (high risk) and was the overall risk rating for structure removal as shown in Figure 2.
