# SPENCER TUCK REGIONAL PARK

# Design Study

PEACE RIVER  
REGIONAL DISTRICT

95% Draft Report  
July 2025

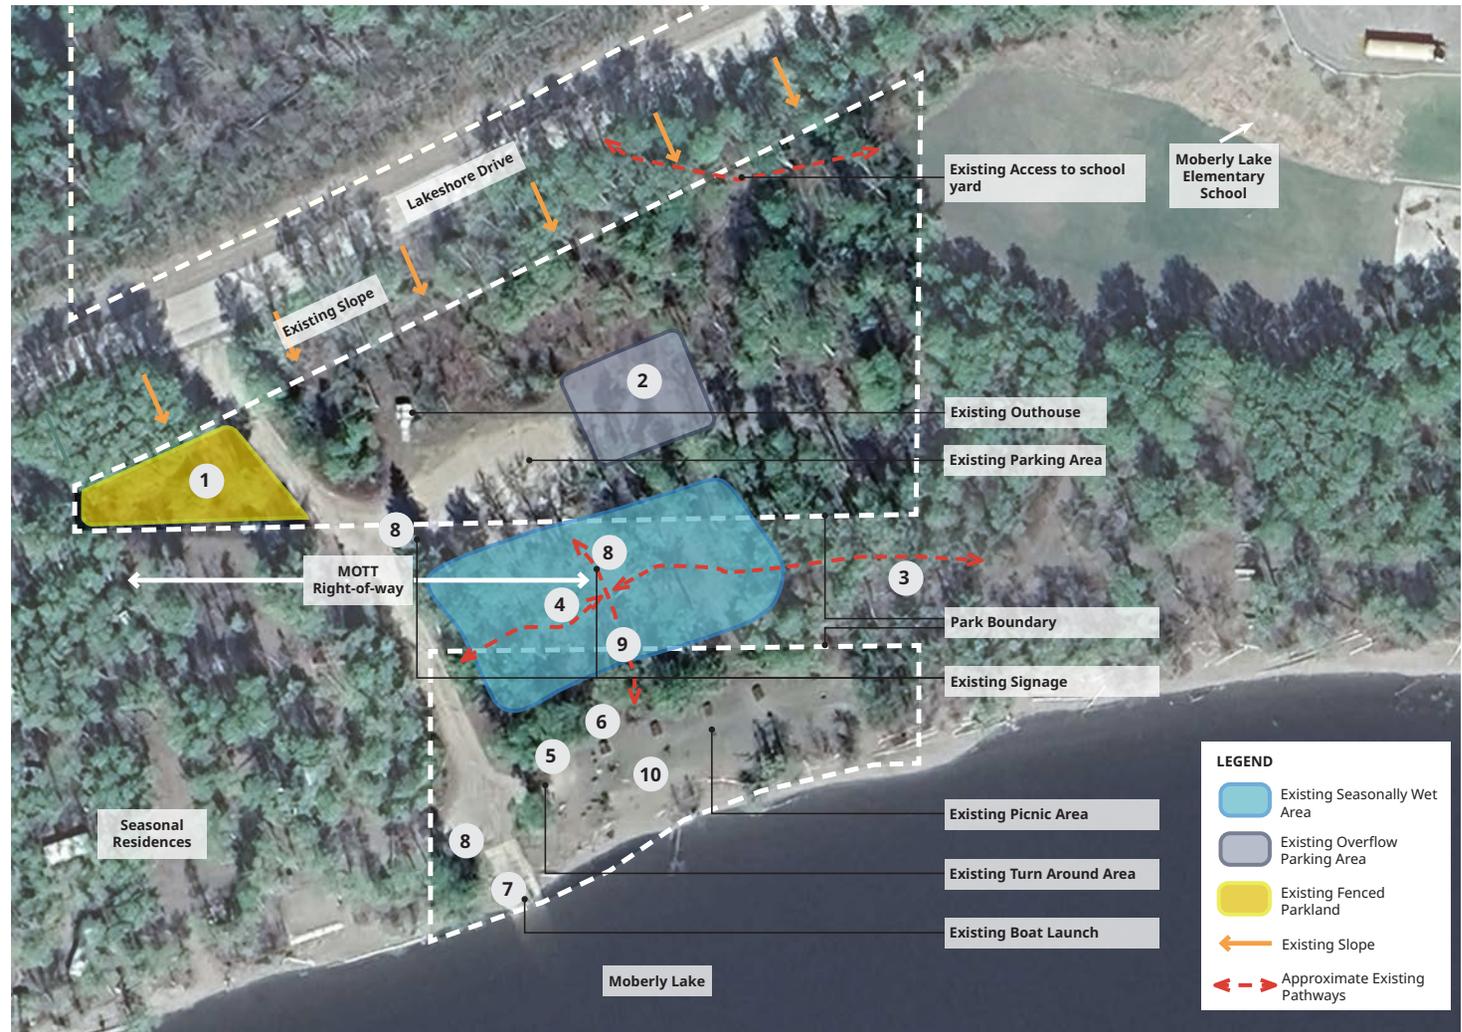
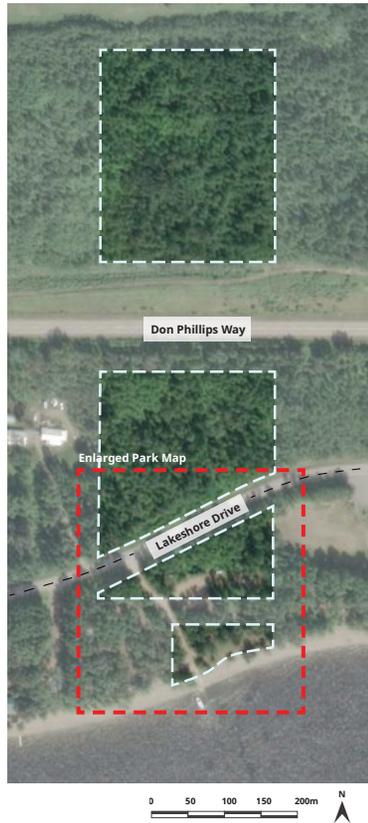
Figure 5: Opportunities and Constraints Map.

Note: Numbered items on the Opportunities and Constraints Map are described in Table 1 on the following page.

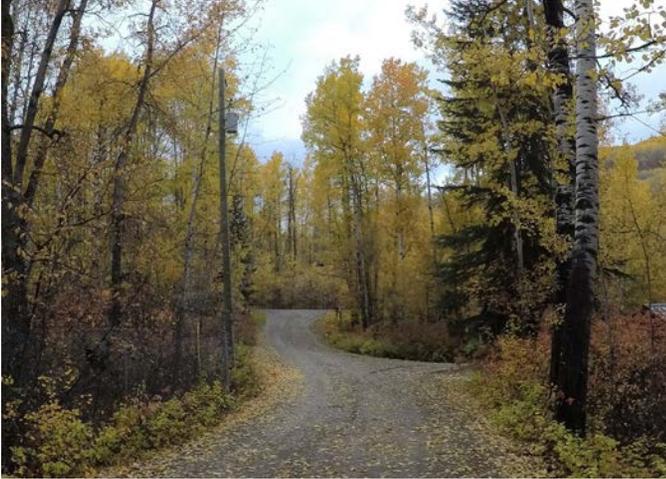
<p>Park Entry Road</p>	<ul style="list-style-type: none"> <li>The park is accessed from Don Phillips Way via Lakeshore Drive. The gravel-surfaced entry drive allows for two-way traffic and leads south from Lakeshore Drive to the parking area and the boat launch.</li> </ul>	<p>Good</p>

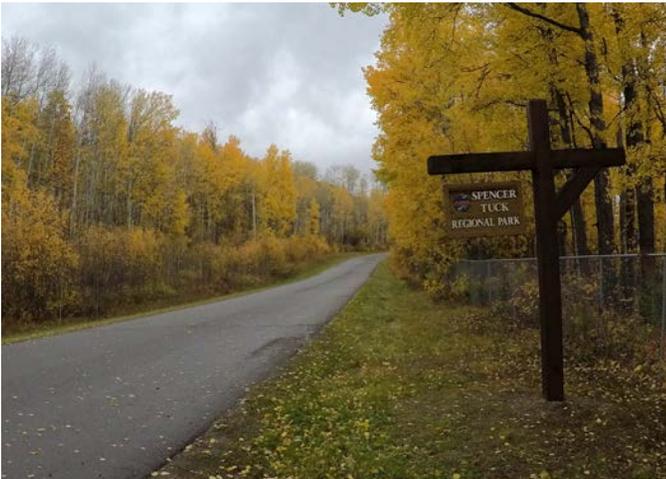
<p>Park Entry Signage</p>	<ul style="list-style-type: none"> <li>Signage identifying park entry access location.</li> </ul>	<p>Good</p>

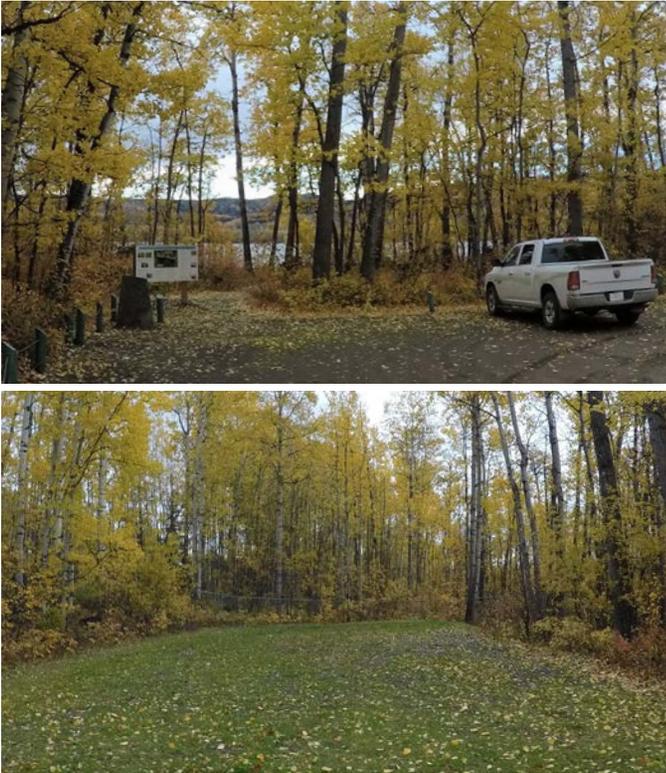
<p>Parking</p>	<ul style="list-style-type: none"> <li>• A gravel parking lot provides unstructured parking for about 10-15 larger vehicles. There is an overflow parking area (currently grass surface) that can accommodate approximately 10 additional parking spots.</li> <li>• There is no designated signage or markings for where to park or circulation in the parking area. There are also no accessible parking spaces demarcated.</li> </ul>	<p>Good</p>

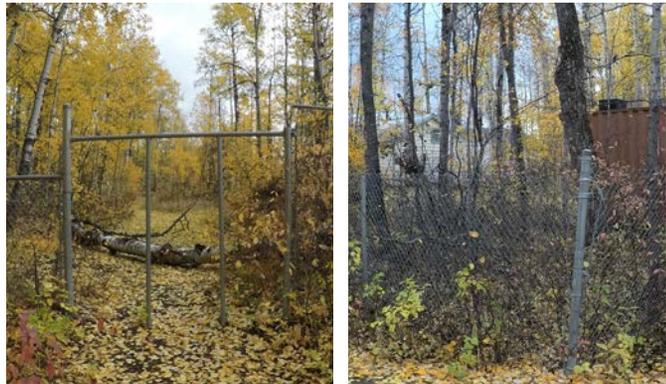
<p>Park Boundary Fence</p>	<ul style="list-style-type: none"> <li>• The park parcel is bounded by chain link fencing on most sides. Height of fencing varies.</li> </ul>	<p>Portions of the fence are in poor condition, but most of the fence is in good – fair condition.</p>

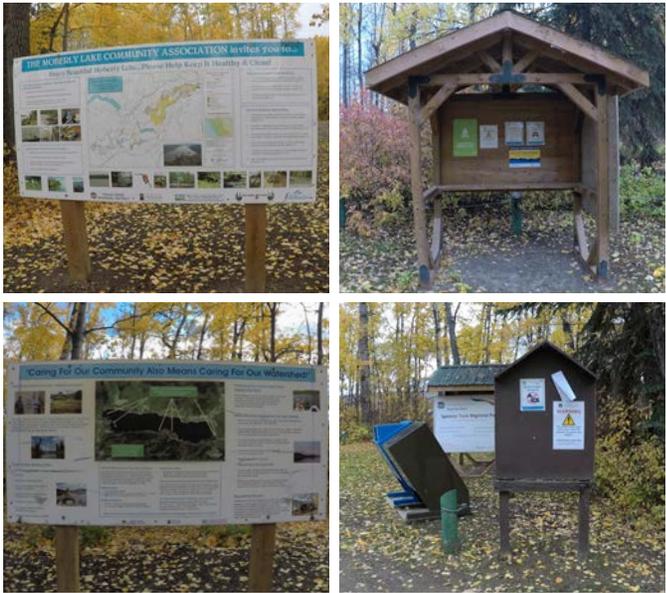
<p>Park Signage / Information</p>	<ul style="list-style-type: none"> <li>• There is signage near the parking area at the trail head that leads to the picnic area that provides information about the local area and watershed.</li> <li>• There is a small covered kiosk and a small uncovered kiosk with regulatory signage posted.</li> <li>• Signage does not contain specific information about the amenities available at the park. For example, there is no map of the park or list of amenities available.</li> </ul>	<p>Good</p>

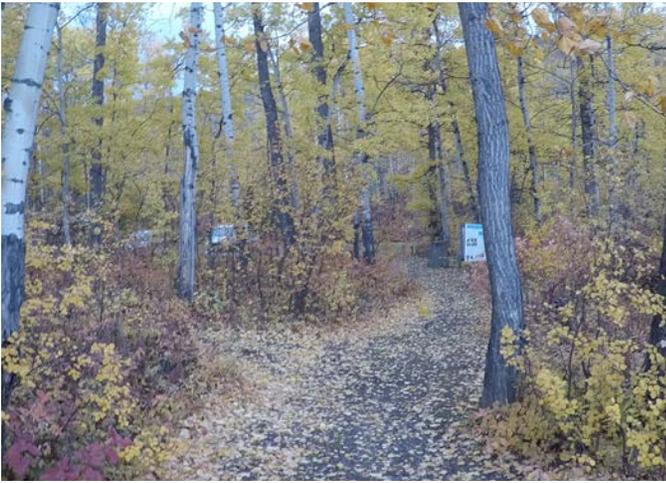
<p>Trails/Pathways</p>	<ul style="list-style-type: none"> <li>• There are natural surface trails located in the forested area between the parking area and the picnic area. One trail leads to the picnic area and another trail leads to the east edge of the property and connects to trails on the adjacent school property.</li> <li>• The area is generally low-lying and can be very saturated in wet conditions.</li> </ul>	<p>Fair  Poor in wet conditions</p>

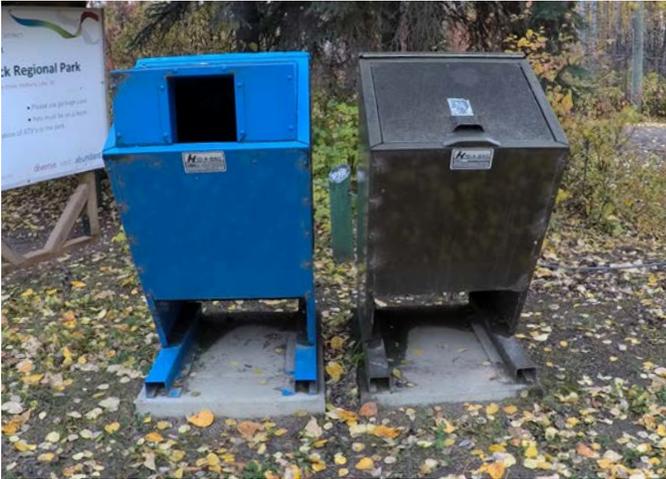
<p>Garbage (3) and Recycling (1) Containers</p>	<ul style="list-style-type: none"> <li>• There is one set of bear-proof garbage containers at the beach and one set of bear-proof garbage/recycling containers located at the parking area. All of the containers are on concrete pads.</li> <li>• Some of the exterior surfaces of the garbage containers require cleaning.</li> </ul>	<p>Good</p>

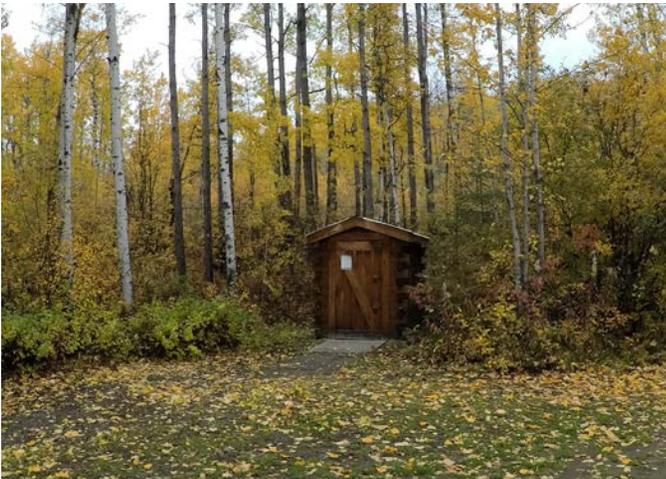
<p>Toilet Building</p>	<ul style="list-style-type: none"> <li>• There is an accessible outhouse building located north of the parking area. The outhouse has a single stall with grab bars; toilet paper and hand sanitizer are provided.</li> <li>• There is a concrete ramp with no clear accessible path to the toilet building, however, the terrain seems firm, stable and reasonable for navigation with a mobility device.</li> <li>• The toilet does not have signage, nor does it indicate having accessible features inside.</li> <li>• This is the only outhouse building on site and is located far from the beach area.</li> </ul>	<p>Good</p>

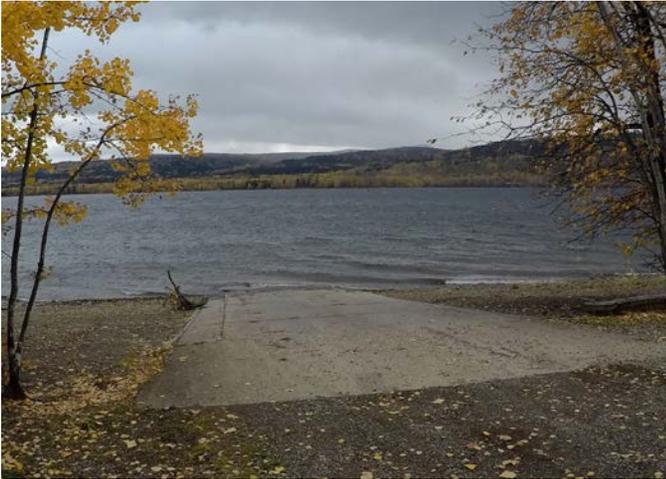
<p>Boat Launch</p>	<ul style="list-style-type: none"> <li>• A concrete boat launch allows for single-vehicle (one-way) access to the lakefront.</li> <li>• Portions of the boat launch surfacing are cracked.</li> <li>• Refer to the engineering study of the boat launch for more details.</li> </ul>	<p>Fair- Poor</p>

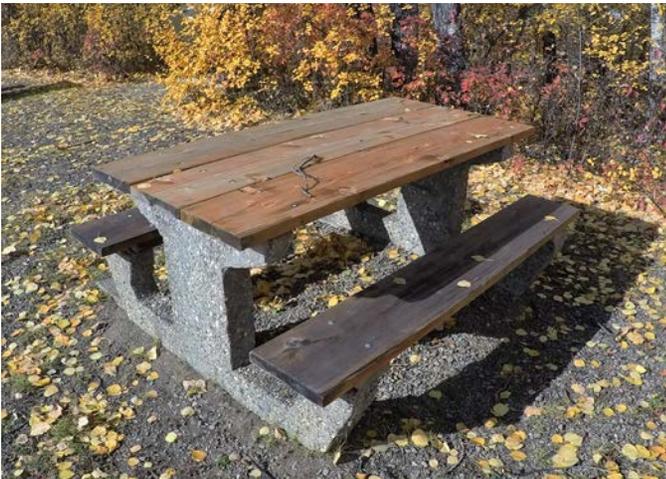
<p>Picnic Tables (5)</p>	<ul style="list-style-type: none"> <li>• Picnic tables with concrete base and wood tops and seats are provided in the beachfront picnic area.</li> <li>• None of the tables have an accessible table extension for wheelchair users or an accessible route leading to them.</li> </ul>	<p>Good</p>

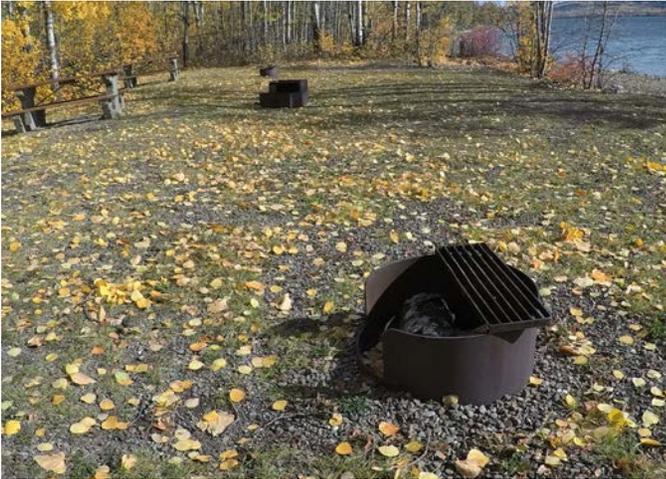
<p>Fire Pits (5)</p>	<ul style="list-style-type: none"> <li>• One steel fire pit is provided for each picnic table.</li> </ul>	<p>Good</p>

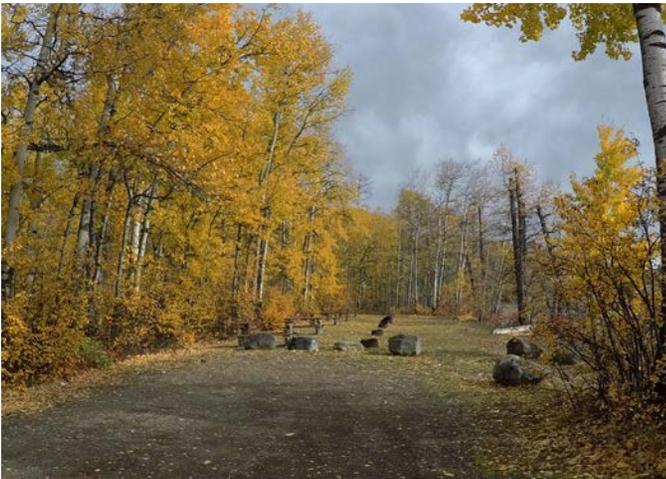
<p>Day Use Temporary Parking, Drop-off/ Turn Around</p>	<ul style="list-style-type: none"> <li>• There is a vehicle turnaround area near the boat launch.</li> <li>• There are some boulders to separate this space from the picnic area. The lack of signage could make it difficult for park users to understand how the space is intended to be used.</li> </ul>	<p>Good</p>

The concepts propose improvement of the existing boat launch turnaround to a minimum 16m depth and 6m width to improve traffic flow and better accommodate longer trailer units. This would include installation of signage to prevent parking within the turnaround. The park entry drive is currently 6m wide, which is ideal for a single-lane launch ramp.

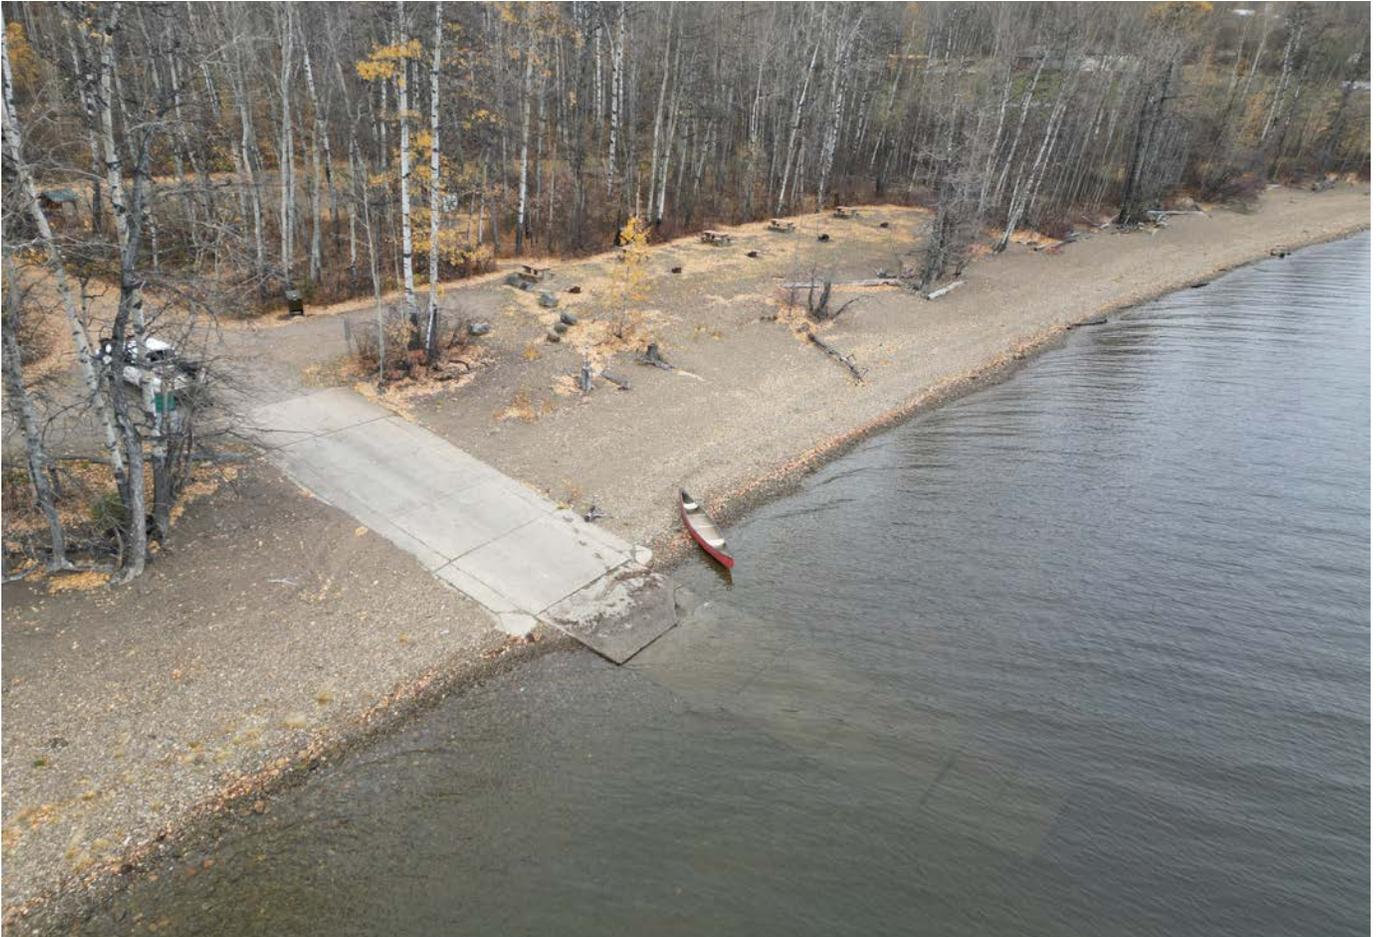
Figure 6: Spencer Tuck Boat Launch, Source: DWB Consulting Services Ltd.

The existing boat launch is located near the southwest corner of the park, with a picnic and recreation beach area to the east. The launch is comprised of what appears to be a combination of pre-cast and cast-in-place concrete panels, with cast-in-place concrete shoulders on the upper portion of the launch. The launch has an average slope of 9.5% and is ~30m long, with upper panels being 4.3m wide, tapering to 2.8m wide below the waterline. At the time of assessment, the end of the launch (the farthest edge of the concrete panels) was ~1.0m below the present water level.

Multiple panels at and near the water line are cracked and have broken corners, as well as have shifted, resulting in drops of 30–60mm (1.5–2.5in) between panels. No exposed metal or other hazards were identified during the assessment. At the time of the site visit, there was evidence that the launch had been used as access for vehicles to drive on the lakeshore beach areas extending west from the launch.

Presently, the uneven surface and damaged panels present minor risks to users if boat trailers track off the narrowing launch panels or cannot clear the uneven panels and impact the exposed edge. Damage and uneven panels are expected to continue developing, especially at the waterline.

The concepts propose boat launch repairs, specifically, replacement of the damaged concrete panels at the waterline and resetting of the surrounding panels to provide a smooth launch surface and ensure safe and functional use. Replacement of the launch with a double-wide launch was also explored to facilitate greater boat use, allowing multiple users to launch at once. One lane has a capacity of approximately 50 launches per day. Demand may currently exceed this level on busy summer days; however, with 15 to 30 trailer parking stalls recommended per lane, there is not enough space available to develop the parking required to support two launch lanes.

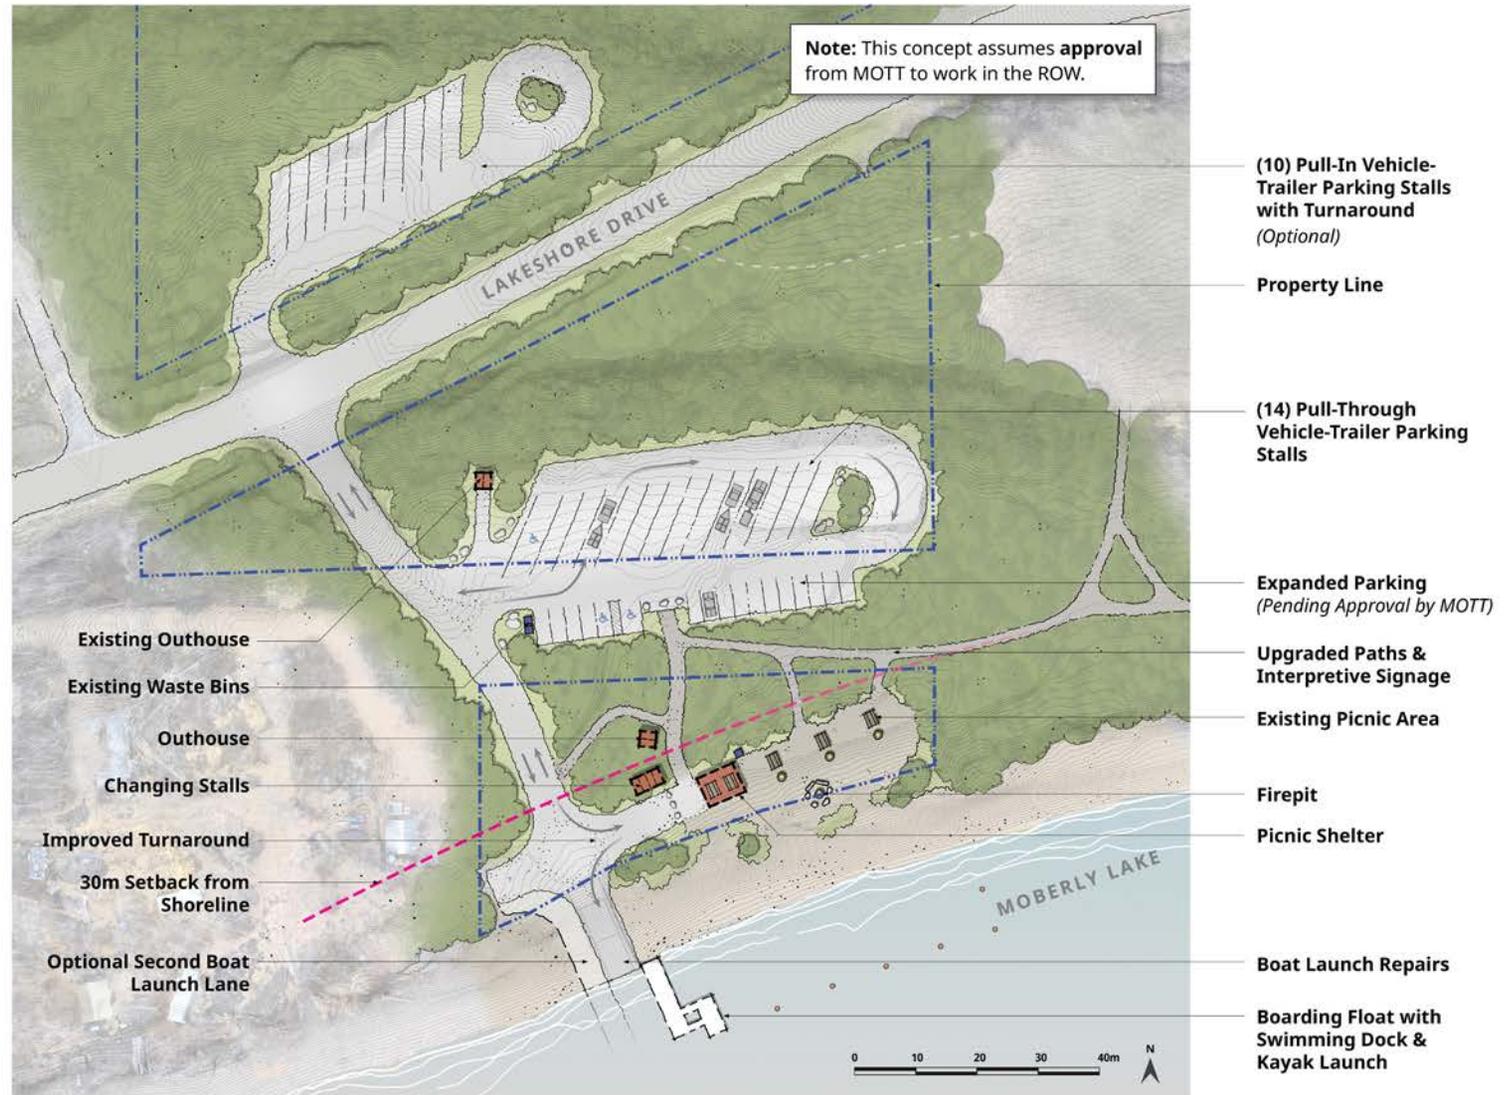
Figure 15: Concept Plan (Preferred Option).

The design recommendations are incorporated into two Concept Plan options illustrated in Figures 15 and 16. The preferred concept plan assumes approval is obtained from the Ministry of Transportation and Transit (MOTT) for work to occur within the existing right-of-way. The alternative concept plan assumes improvements must occur outside of the right-of-way.
